**IN THE UNITED STATES DISTRICT COURT  
FOR THE NORTHERN DISTRICT OF GEORGIA**

## COMPLAINT

8. Between April of 2021 and January of 2023, Mr. and Mrs. Castan purchased a Jomar model T 412G ball valve for use in the plumbing system in their residence.

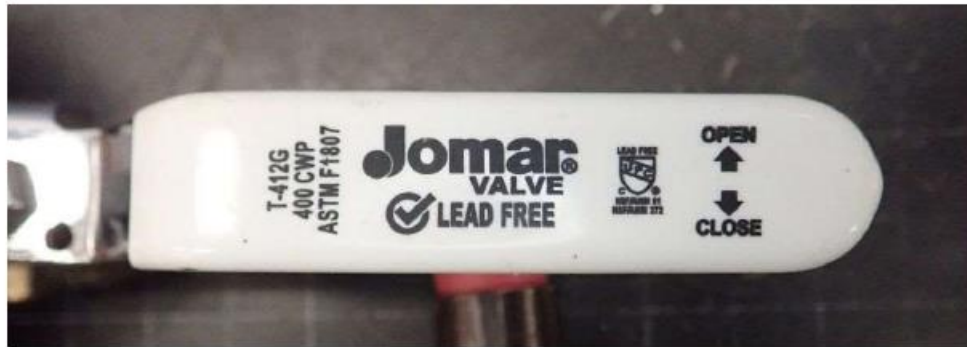
9. A photograph of the subject ball valve's identification marking is set forth below:

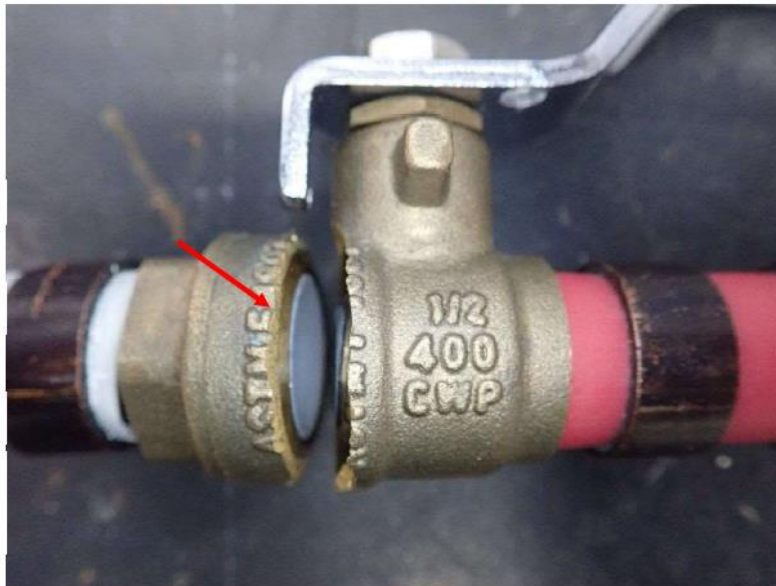
11. The Jomar ball valve split and separated at threaded connections of the two halves of the valve as shown in the photograph below:

12. The fracture was at a connection made at the time of the manufacturing of the Jomar ball valve and is not a connection tightened by the installing plumber.

13. The Jomar ball valve is made of brass.

15. Brass is subject to a failure mechanism known as stress corrosion cracking when the percentage of zinc in the alloy is above 15 percent.

16. The Jomar ball valve split while operating under normal and expected water pressure because of design and manufacturing defects with the ball valve, including, but not limited to, designing and manufacturing the Jomar valve with too much zinc.
